# VEHICLE INSPECTION REPORT

**WJ65YVK**

## Isuzu D-Max 2.5 TD

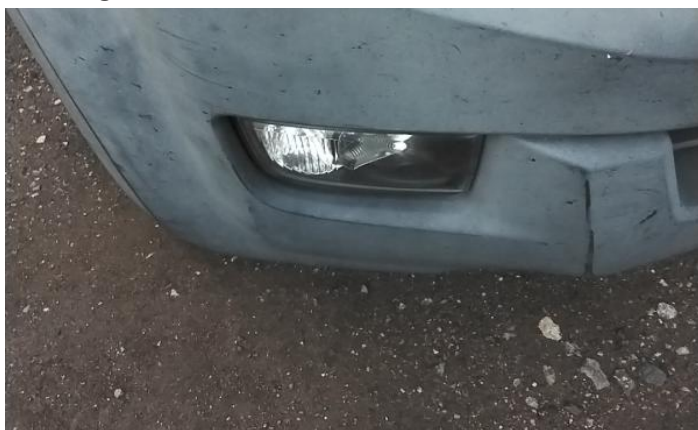
1: Bumper Front  
Scratched  
Over 100mm Thru Paint

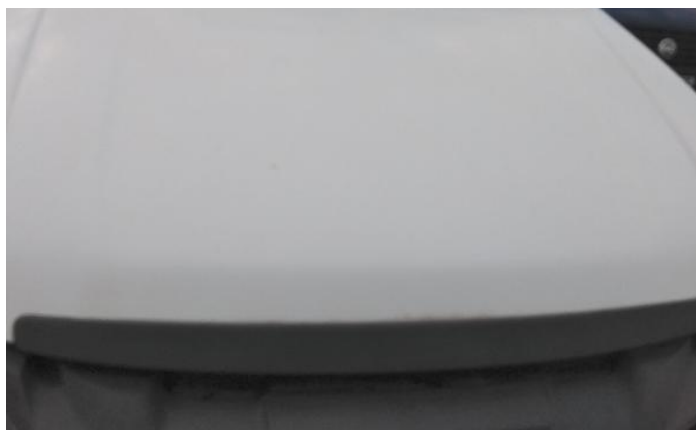
2: Bonnet  
Chipped  
Multiple Chips

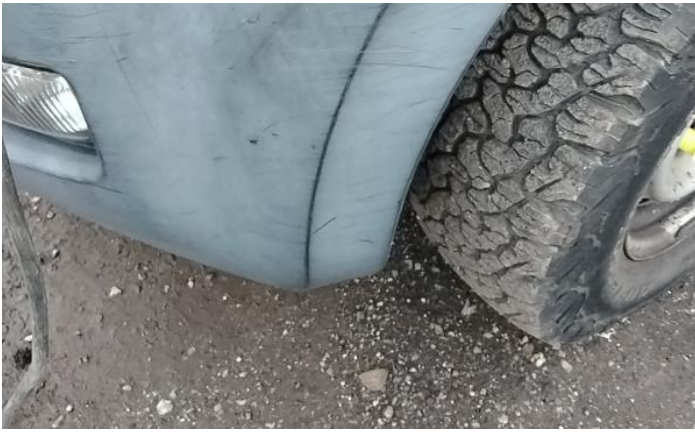
3: Bumper Front  
Scratched  
Over 100mm Thru Paint

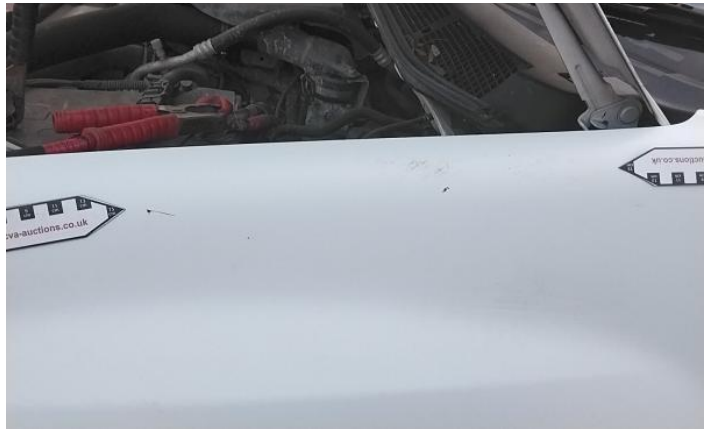
4: Wing nsf  
Scratched  
Over 25mm Thru Paint

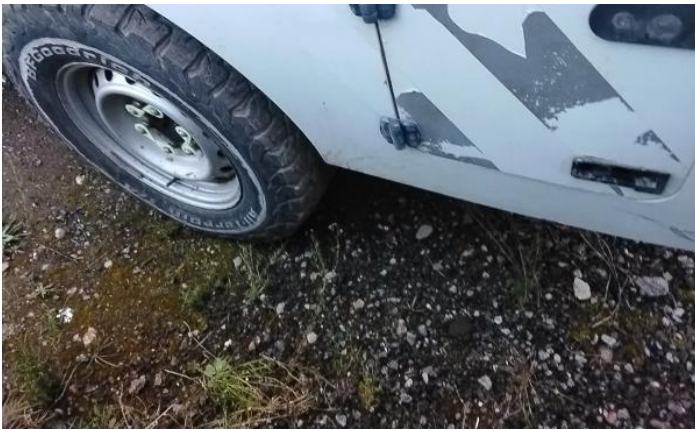
5: Qtr Panel nsr  
Scratched  
Over 25mm Thru Paint

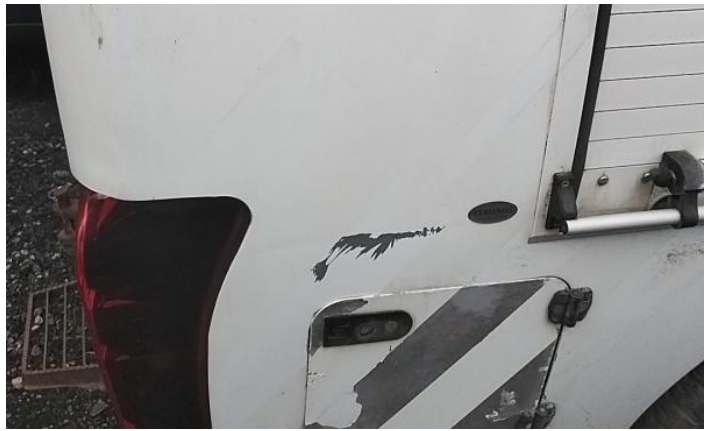
6: Qtr Panel osr  
Scratched  
Over 25mm Thru Paint

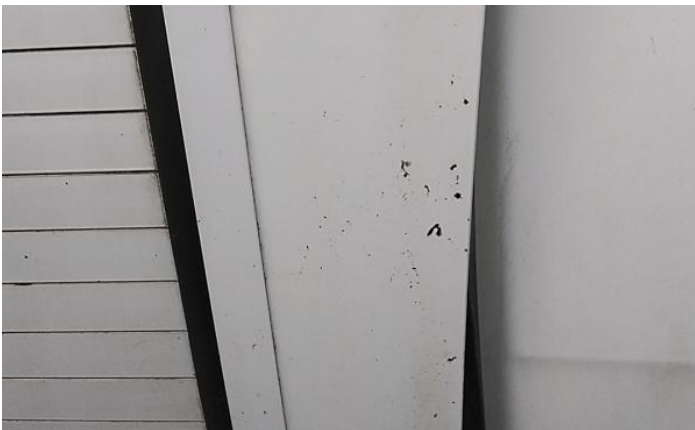
7: Qtr Panel osr  
Chipped  
Multiple Chips

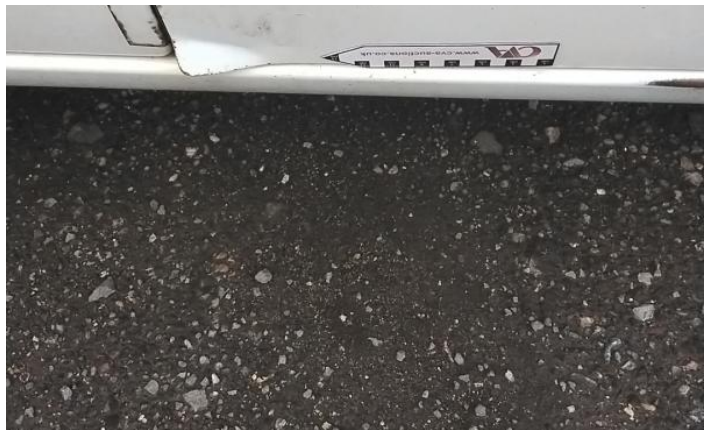
8: Door osf  
Dented  
With Paint Damage

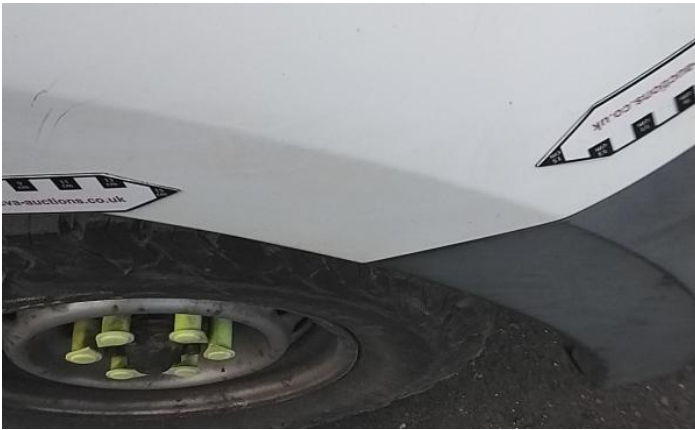
9: Wing osf  
Dented  
Over 30mm

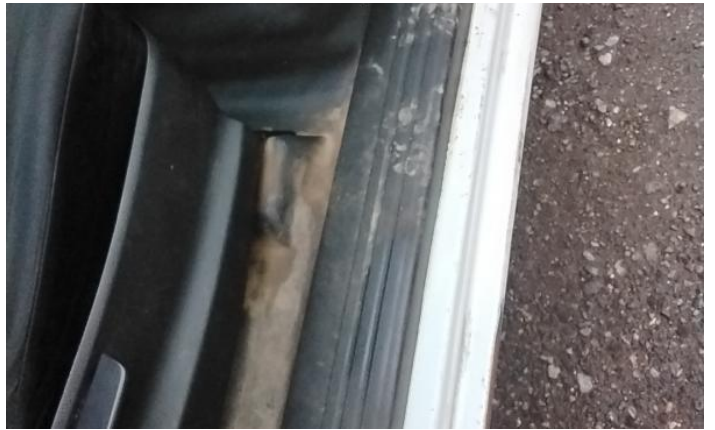
10: Carpets Front  
Soiled  
Heavy

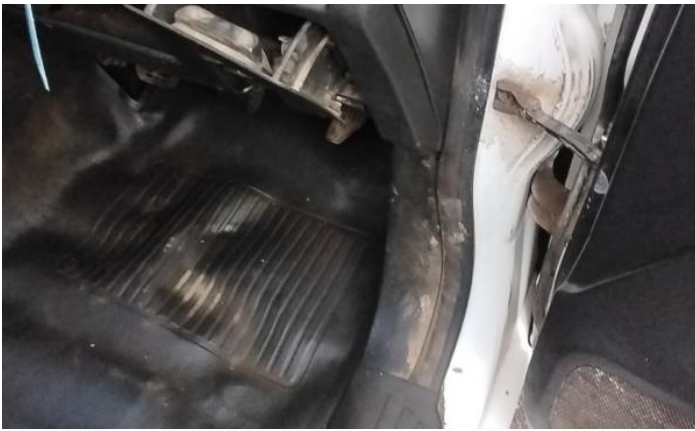
11: Fascia Panel  
Broken  
Replace

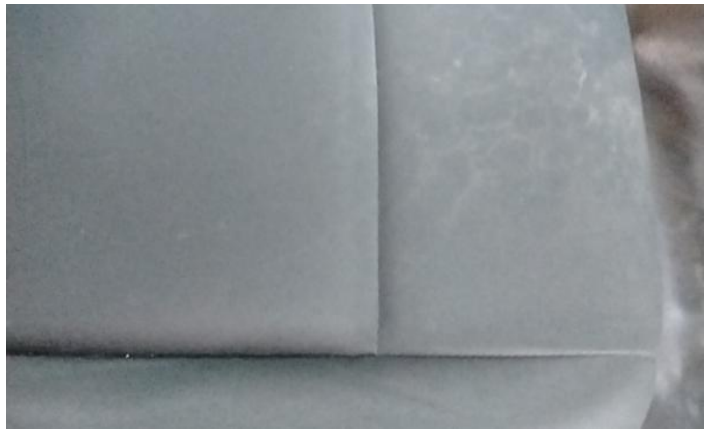
12: Seat Base Cover osf  
Soiled  
Heavy

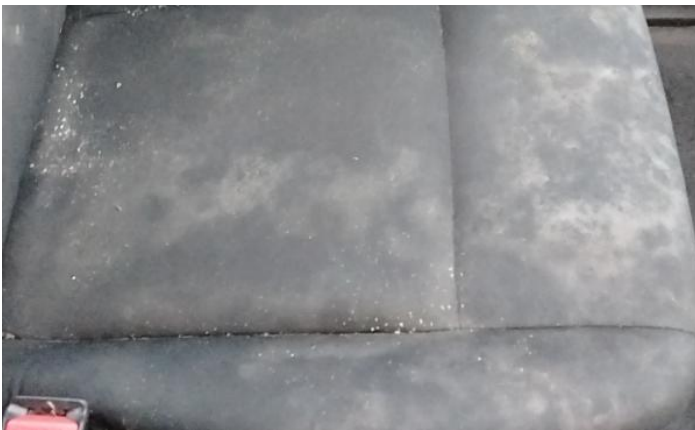
13: Seat Base Cover nsf  
Soiled  
Heavy

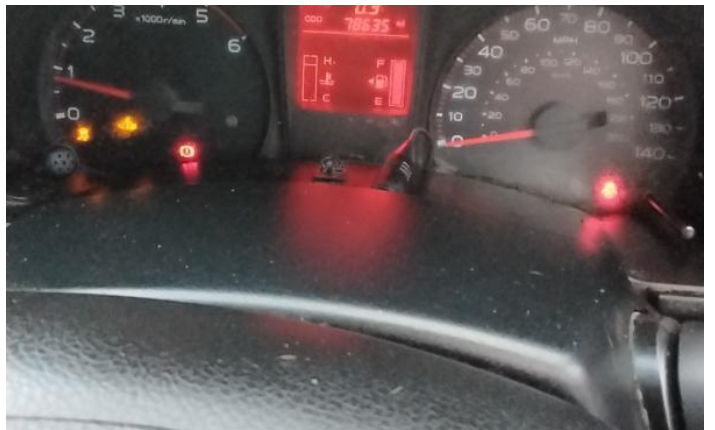
14: Dash Warning Lights  
Displayed  
No Action
